WARREN MILL DAM

NJ 00765

PHASE 1 INSPECTION REPORT
NATIONAL DAM SAFETY PROGRAM

MARCH 1981

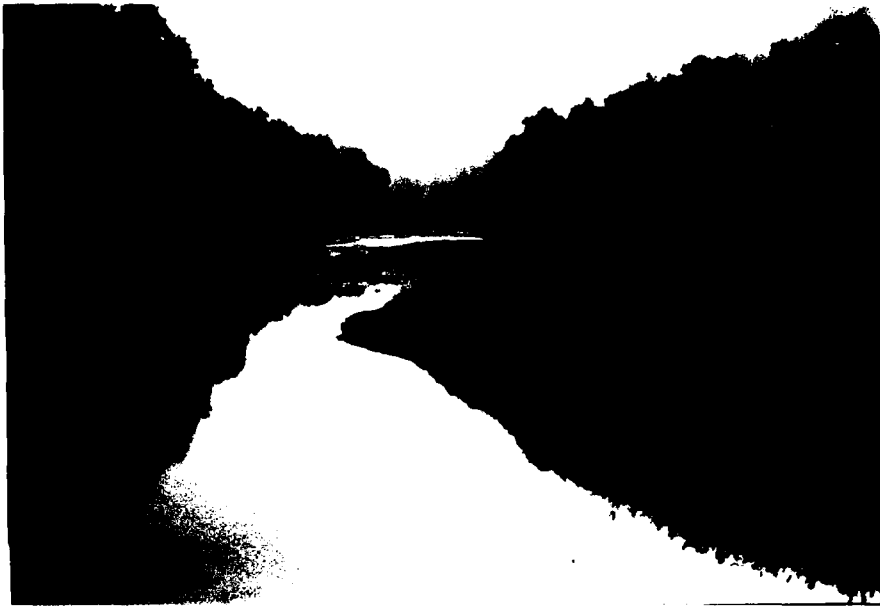
VISUAL EXAMINATION OF	OBSERVATIONS	REMARKS OR RECOMMENDATIONS
SLOPES	Steep slopes on both sides. Slope flat to lever near reservoir.	The reservoir is a long gorge.
SEDIMENTATION	Very heavy, particularly near the dam. Accumulation of silt up to a few feet below crest.	Entire impoundment area reduced by siltation.
	ix

August, 1980
View of Reservoir from Spillway Crest

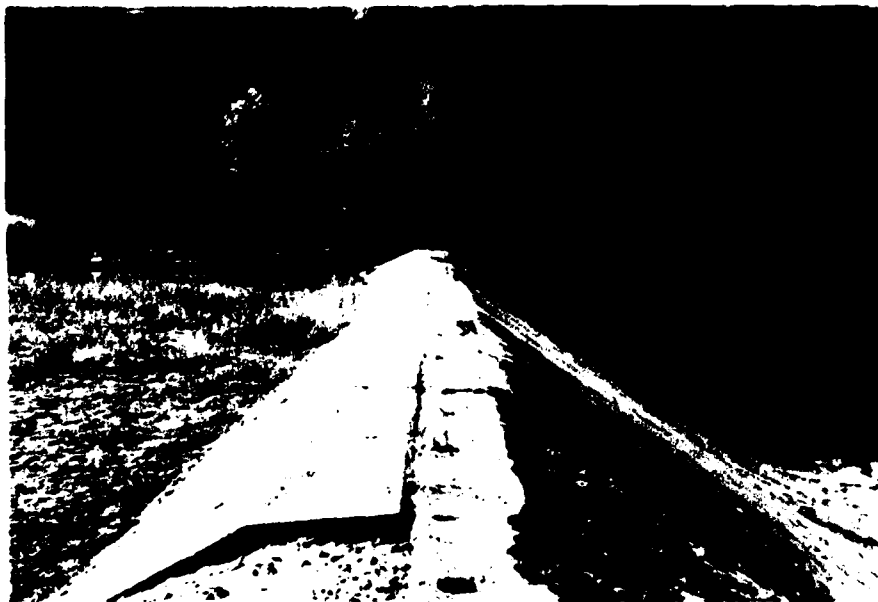
VISUAL EXAMINATION OF	OBSERVATIONS	REMARKS OR RECOMMENDATIONS
UPSTREAM END OF EMBANKMENT	Heavily silted. Silt accumulation up to a few feet below crest.	Silt impacting heavy load on spillway and should be removed to increase storage capacity.
JUNCTION OF EMBANKMENT AND ABUTMENT, SPILLWAY AND DAM	Good on left side of spillway to canal lock and from lock to left abutment. Fair on right side of spillway to right abutment.	
ANY NOTICEABLE SEEPAGE	None observed on embankment portion.	
STAFF GAGE AND RECORDER	None Observed.	
DRAINS	None Observed.

August, 1980
Siltation at Spillway Crest

(2) Remove heavy siltation on the upstream side of the spillway to reduce the load on the structure and to increase storage capacity.

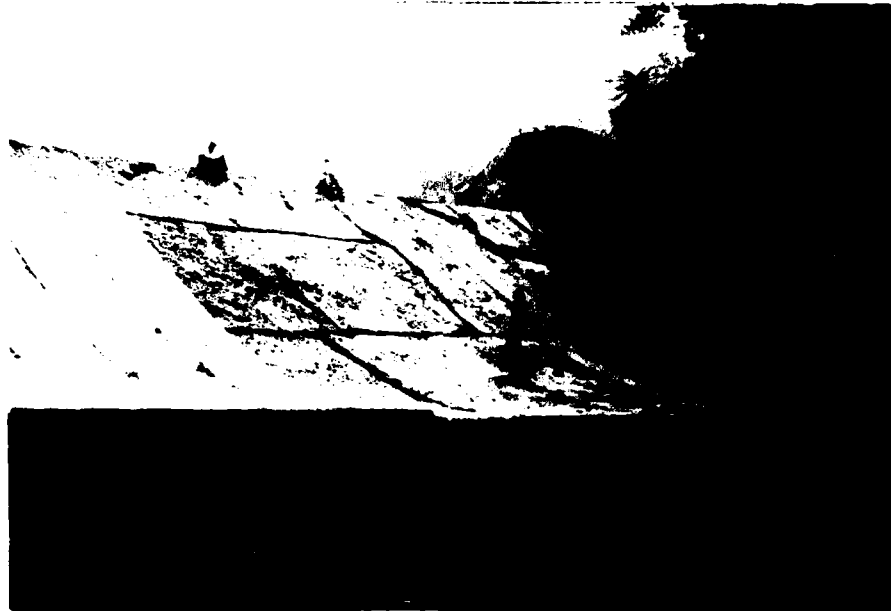
VISUAL EXAMINATION OF	OBSERVATIONS	REMARKS OR RECOMMENDATIONS
SURFACE CRACKS CONCRETE SURFACES	Spillway ogee surface badly deteriorated. Large portion of ogee surface concrete peeled off. Coarse gravel surface of mass concrete showing	Main mass of concrete spillway appears as rock/gravel fill solidified with lean concrete. This mass was then covered over with structural concrete. Re-bars can be seen at cracks, near the ogee surface. Requires immediate patching.
STRUCTURAL CRACKING	Large and deep cracks present throughout.	
VERTICAL AND HORIZONTAL ALIGNMENT	No evidence of either movement (hor.) or settlement (vert.) in concrete portion of dam.	Some displacement of base slab.
MONOLITH JOINTS	N/A	
CONSTRUCTION JOINTS	Open throughout in varying degrees and badly spalled. iii	Requires immediate patching and eventual long term repairs.

August, 1980
View of Spillway Deterioration

a. Temporary concrete patching of the deteriorated portions of the spillway should be undertaken within thirty days from the date of approval of this report to forestall further damage.

(1) Initiate engineering studies, including structural and foundation investigations, in order to plan and design longterm repairs for the spillway structure.
